## Education Service

# Path Erosion and Management

### Path Erosion in the Lake District

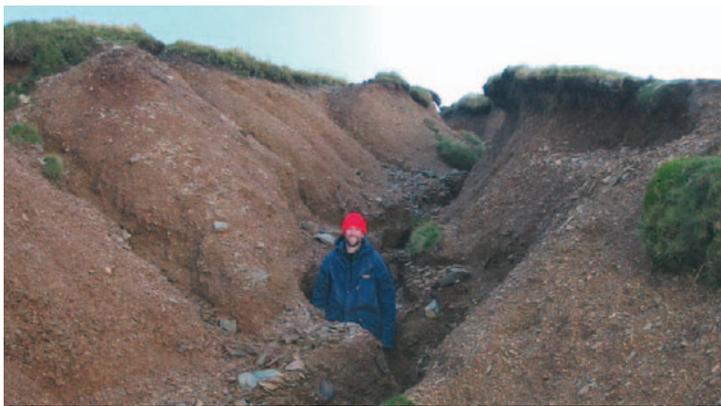
The photo appears to show a river gully. In fact this is the path that runs from Coledale Hause towards Wandope, near Buttermere. No work has ever (yet) been done to this path, and it demonstrates what other paths in the Lake District could look like if nothing was done to stabilise them.

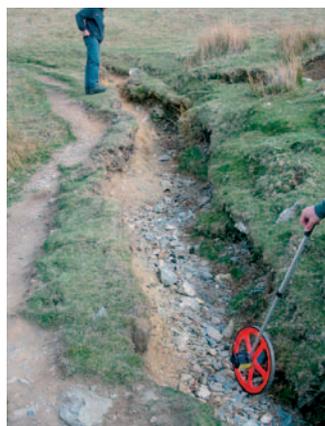
April 2003

These two photos are taken at the same location. The original path had become so deep and loose that a second path had developed alongside. Soil was being lost into nearby watercourses. The section of path requiring management was just 20m long, but with quite a steep gradient. The best solution was to pitch a path. It is far better to catch a developing problem rather than leave it. If left, the material loss is far bigger, and repairs may not be as successful.

The work here was carried out by the National Trust.

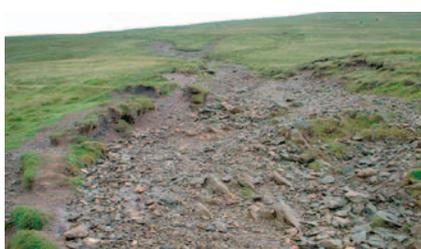
July 2002

By the late 1990s, there appeared to be a wide, straight, white road built on the side of Helvellyn. This was actually an erosion scar. It was 8m wide and covered a distance of nearly 300m.

A sub-soil path would provide the best solution on this sort of terrain, but there was no access route to the site.

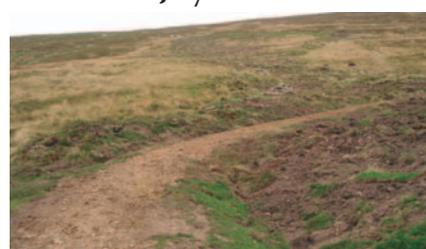
October 2003

A digger was dismantled, flown up onto the hill in sections and rebuilt on site.

The path was then repaired by contractors using the soil inversion technique. The result was excellent. In just over a year, the erosion scar was almost invisible, the new path looked entirely 'natural' and is comfortable and pleasant to walk on.
